**MASSACHUSETTS COASTAL BASIN
PEABODY, MASSACHUSETTS**

**FOUNTAIN POND DAM
MA 00191**

**PHASE I INSPECTION REPORT
NATIONAL DAM INSPECTION PROGRAM**

OCTOBER 1979

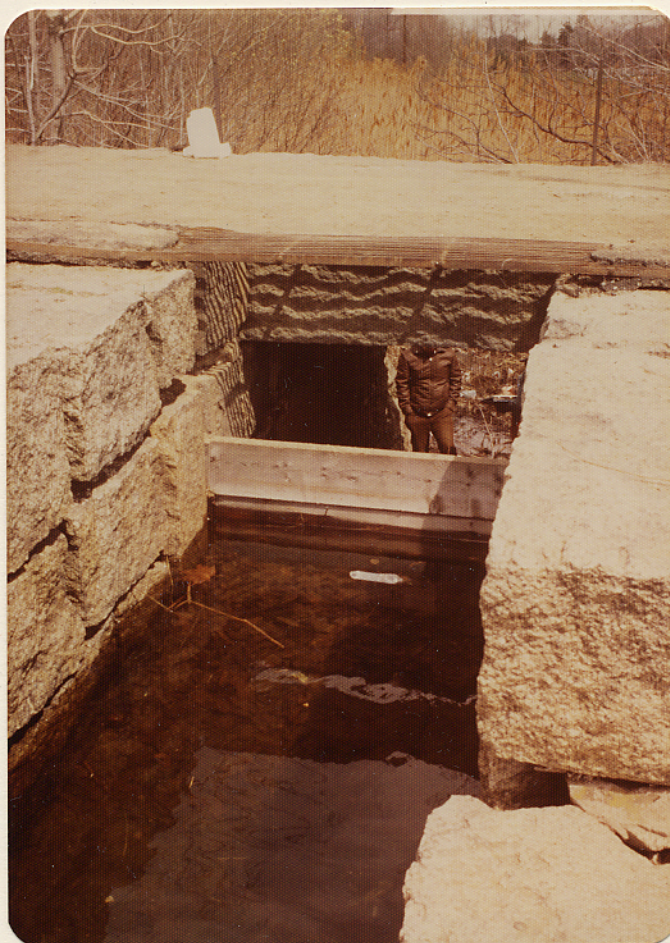
Leaves and soil have settled out upstream of the stoplogs on the spillway. Much of the mortar has been lost between the granite blocks. Debris and several small boulders were observed in the discharge channel. Trees are growing along the east side of the channel.

NO. 2 UPSTREAM VIEW OF SPILLWAY AND STOPLOGS

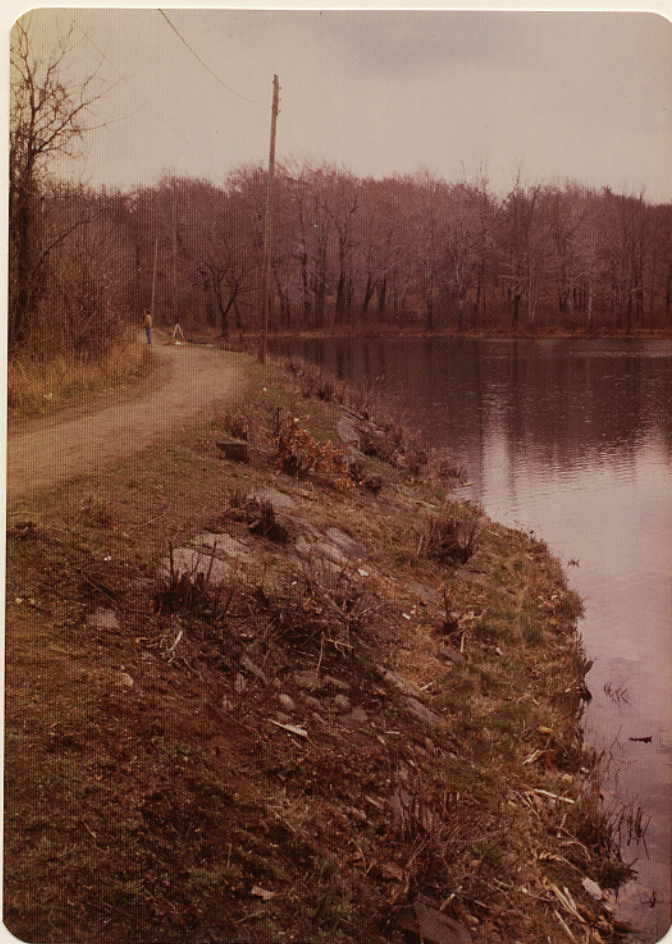
The upstream slope of the dam is generally covered with riprap, however, there are several areas where the riprap is missing. Many small bushes are growing on the upstream slope. These have been cut back in the past but not removed (see photographs No. 4 and No. 5). There is evidence of trespassing on most of the upstream slope.

the loss of some riprap and undermining of the remainder (see Photographs C-4 and C-5). Erosion on the downstream slope is undermining the left wing wall of the discharge channel. Trees and brush are growing on the upstream and downstream slope of the dam (see Photographs C-4 and C-7). Trash and other debris cover the downstream slope of the dam in many places. The mortar and chinking between the stonework in both the spillway and discharge channel is missing or is in very poor condition. Both the floor of the spillway and the floor of the discharge channel are covered with silt and debris such that their condition cannot be determined (see Photographs C-2 and C-6). There are several small trees overhanging the discharge channel.

NO. 4 BRUSH GROWING ON RIPRAP ON UPSTREAM SLOPE

- (1) initiate a program of selective clearing of trees, brush and roots from both slopes of the dam and from the sides of the spillway discharge channel. All excavations resulting from removal of stumps and roots should be backfilled with selected materials;
- (2) divert the discharge from Browns Pond line away from the toe of the dam;
- (3) replace mortar between the stone blocks in the spillway;
- (4) repair erosion on the upstream slope of the dam, replacing any missing riprap;
- (5) remove all trash and debris from the downstream slope and discharge channel;
- (6) implement a systematic program of maintenance inspections. As a minimum, the inspection program should consist of a monthly inspection of the dam and appurtenances, supplemented by additional

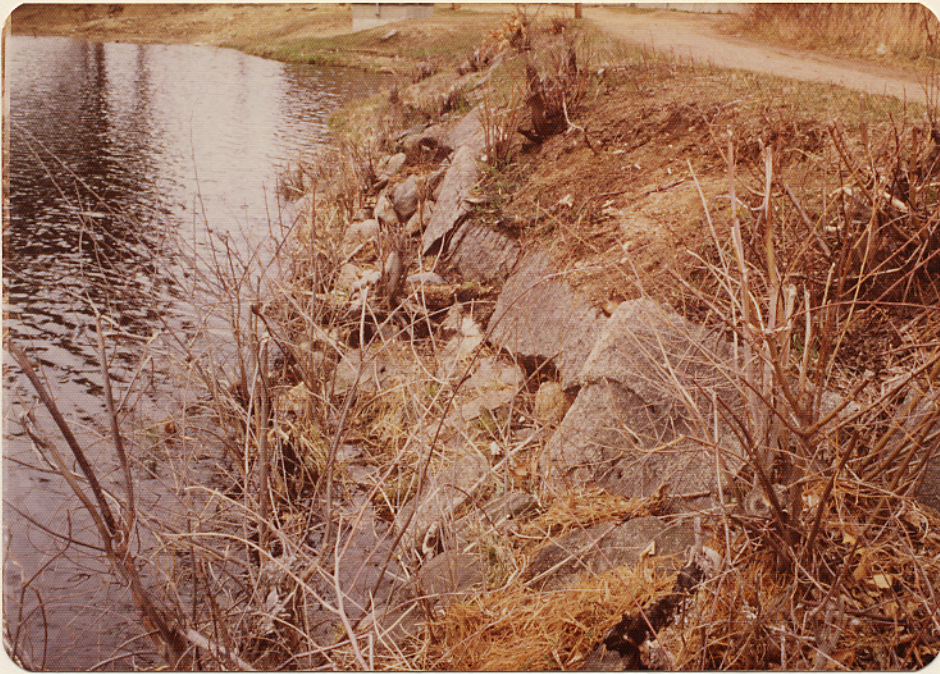
NO. 5 RIPRAP ON UPSTREAM SLOPE

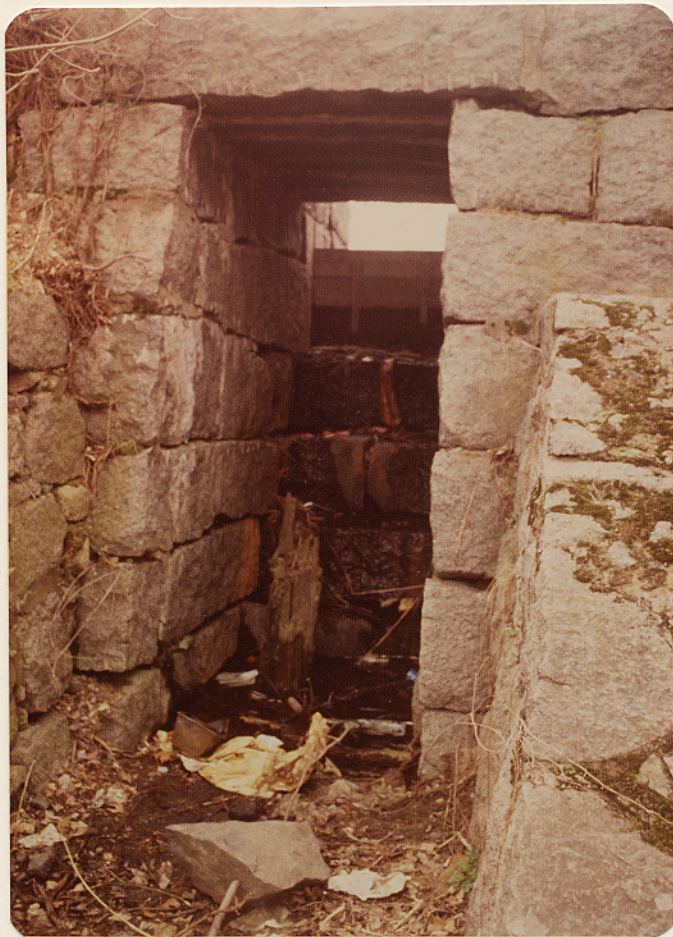
The mortar and chinking between the stone blocks has for the most part, been lost (see Photograph C-6) leaving large continuous voids between the blocks. Leaves, trash and other debris have accumulated against the stoplogs in the spillway. Water was leaking at about 3 to 4 gallons per minute around the stoplogs through one open joint on the left abutment.

NO. 6 DOWNSTREAM VIEW OF SPILLWAY

inspections during and after severe storms. Maintenance should include clearing of debris from the spillway and discharge channel, clearing of trees, brush and debris from the slopes, and repair of erosion to slopes, or to the mortar in the spillway. All repairs should be undertaken in accordance with all applicable State regulations;

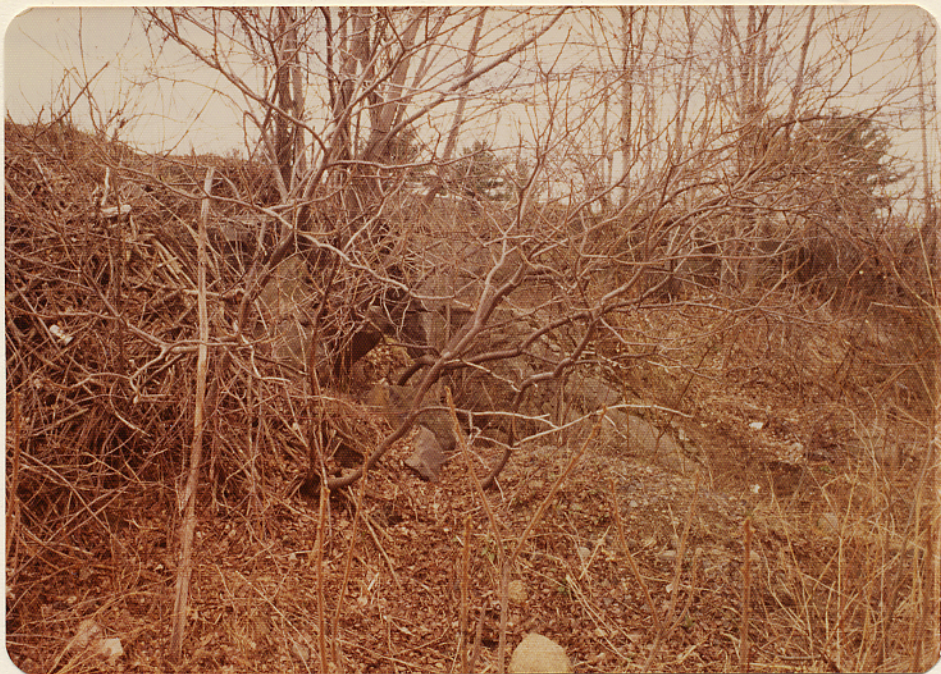
NO. 7 DOWNSTREAM SLOPE OF DAM

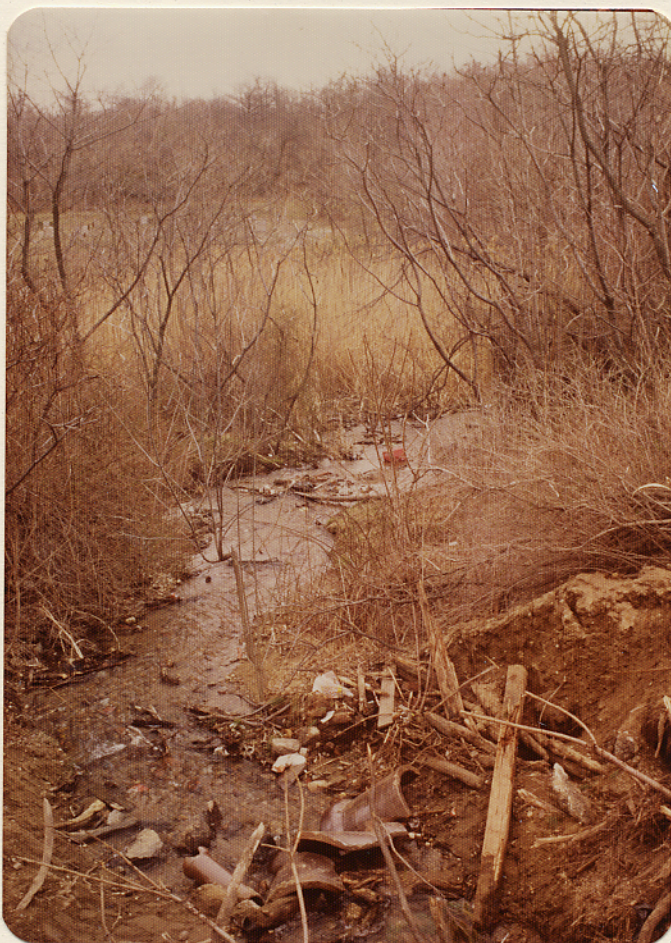
c. Discharge Channel	Mortared & dry stone masonry.
General Condition	Fair-voids between stones-with weeds growing-at bottom some erosion behind stones.
Loose Rock Overhanging Channel	Some dumped rock held back by saplings
Trees Overhanging Channel	Some saplings on Rt. abutment
Floor of Channel	Covered with debris and 2 small boulders
Other Obstructions	None

NO. 8 DOWNSTREAM DISCHARGE AREA
